SWORN STATEMENT IN PROOF OF LOSS

Interim Claim Analysis Report

Coral Realty

129 3rd Avenue, New York, NY 10013

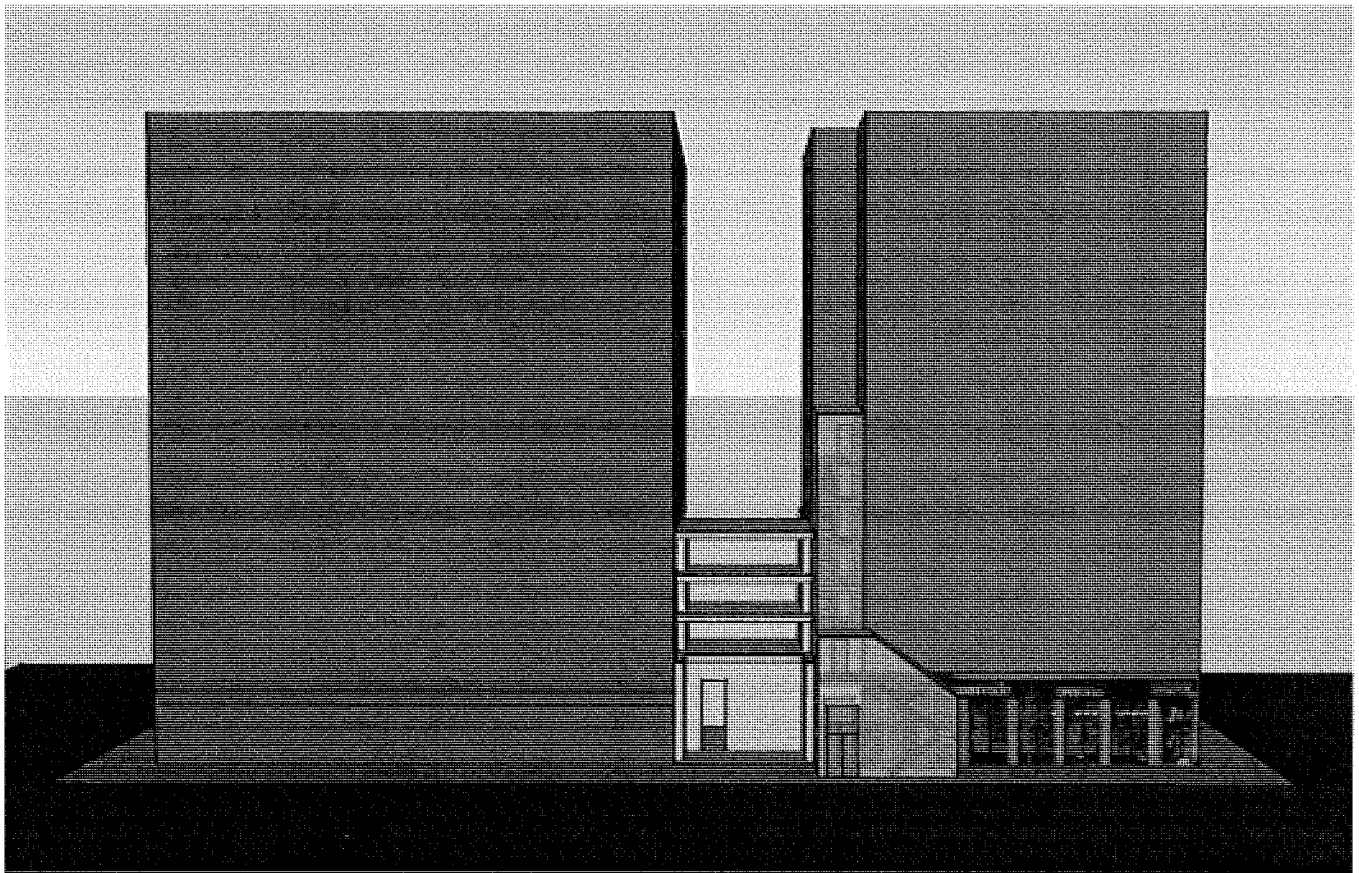
Coral Realty
129 Third Ave, New York, NY 10003
GGG/Al Proposed Staircase Structure Diagram

- Assuming NYCDOB does require the type of structure being claimed, please advise of the following:
 - Why is the temporary tower (12'x24') twice the size of the existing emergency egress (6'x12') that is going to be off line during the repairs?

- What structural engineering analysis was being referenced for the necessity of a concrete foundation required for the temporary stair tower?

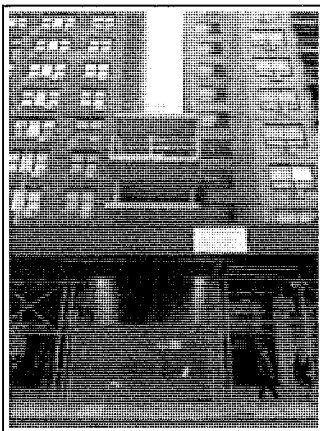
1	Coral Realty	
	Field Photo Report	
	Location:	Exterior
	Prepared By:	DBI
	Photo Date:	05/27/2015
Description: East elevation of subject property, concrete structure, and neighboring building from 3rd Avenue.

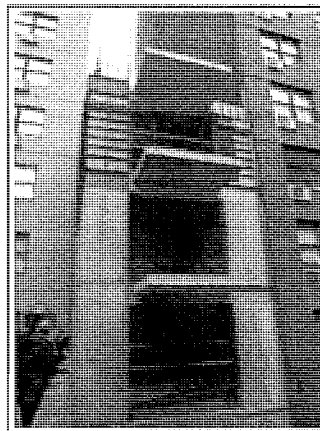
2	Coral Realty	
	Field Photo Report	
	Location:	Exterior
	Prepared By:	DBI
	Photo Date:	08/15/2015
Description: West elevation of concrete structure from rear roof of subject property.

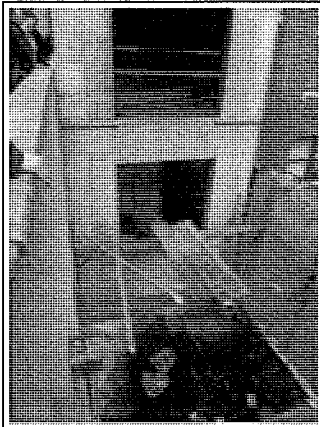
3	Coral Realty	
	Field Photo Report	
	Location:	Exterior
	Prepared By:	DBI
	Photo Date:	08/22/2015
Description: View from rear roof of subject property showing lower half of adjoining structure.

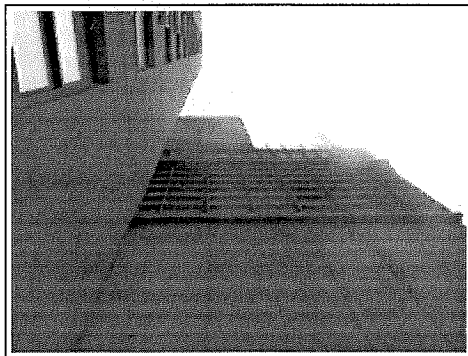
7 Photo No.	Coral Realty	
	Field Photo Report	
	Location:	Exterior
	Prepared by:	DBI
	Photo Date:	04/07/2015
Description: North elevation of concrete structure showing formwork in place.

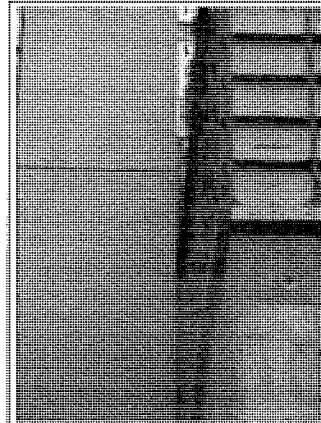
8 Photo No.	Coral Realty	
	Field Photo Report	
	Location:	Exterior
	Prepared By:	DBI
	Photo Date:	08/22/2015
Description: West elevation of concrete structure showing formwork in place.

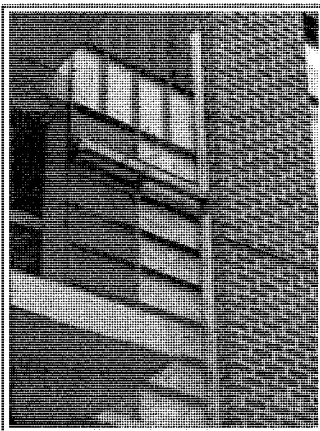
9 Photo No.	Coral Realty	
	Field Photo Report	
	Location:	Exterior
	Prepared By:	DBI
	Photo Date:	06/22/2015
Description: North elevation view of concrete structure showing formwork connection to neighboring building.

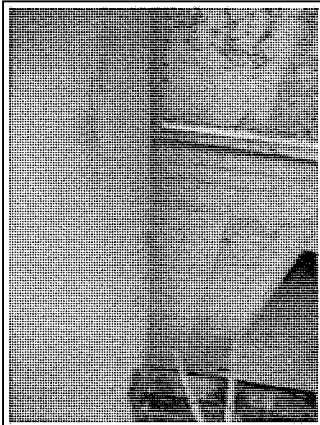
11 Photo No.	Coral Realty	
	Field Photo Report	
	Location:	Exterior
	Prepared By:	DBI
	Photo Date:	08/25/2015
Description: West elevation view of concrete structure where it abuts the subject property.

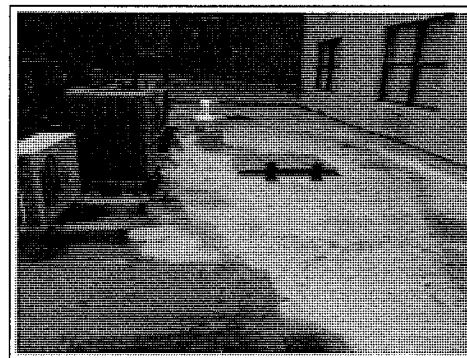
12 Photo No.	Coral Realty	
	Field Photo Report	
	Location:	Exterior
	Prepared by:	DBI
	Photo Date:	06/16/2015
Description: View of subject property 2nd story roof.

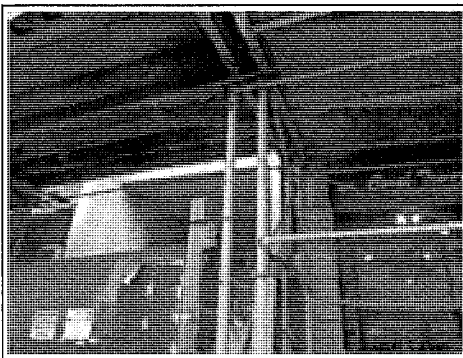
17
 Photo No. Description: View of scaffolding present at subject property entrance at 3rd Avenue.

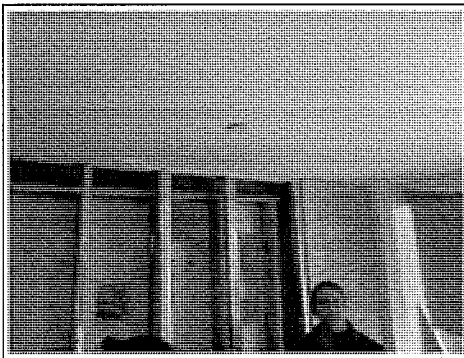
25
Photo No. Description: Overview of double wall system in apartment. Double wall system was erected for testing purposes.

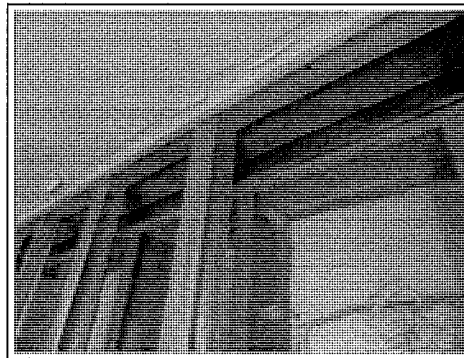
26
Photo No. Description: View of temporary wall system erected for testing purposes.

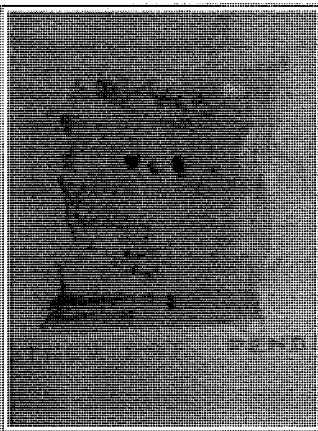
27
Photo No. Description: View of temporary wall system erected for testing purposes.

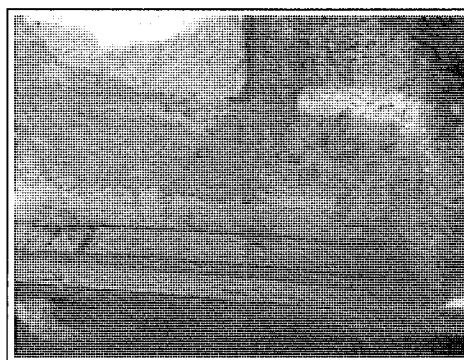
28
Photo No. Description: Detail view of wall section.

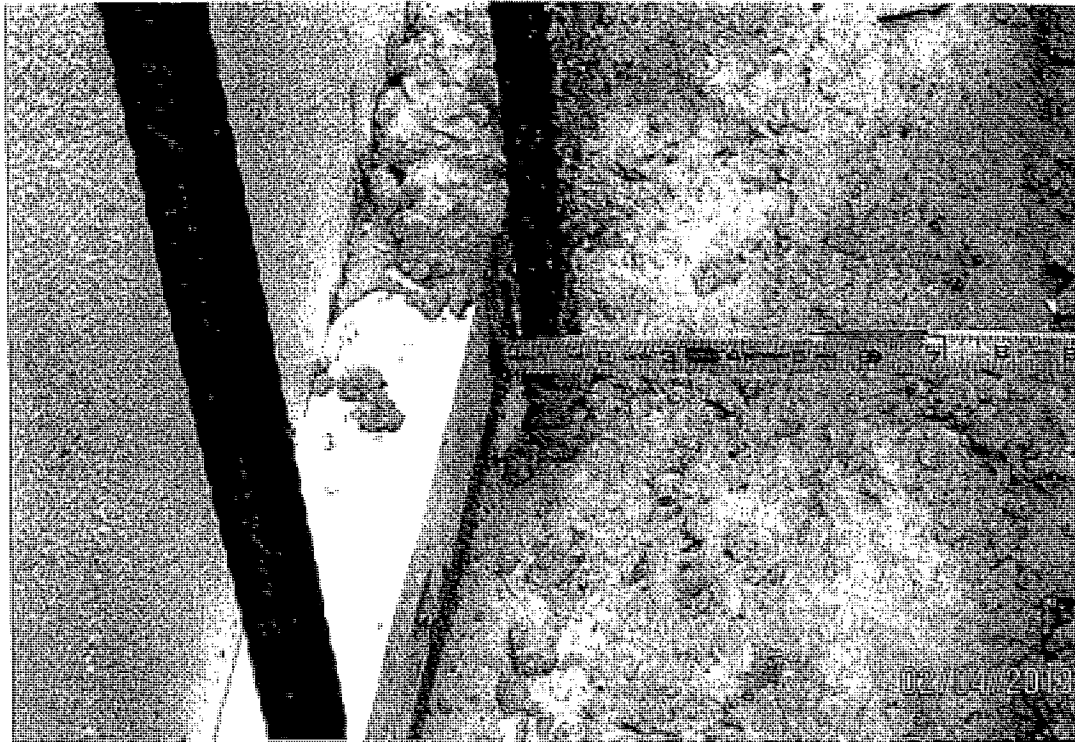
IF YOU ALLOW FOR 2 INCH STYROFOAM BELOW
THEN 4 1/2 INCH ENCROACHMENT.

ALL SUBJECT TO FINAL THIRD PARTY SURVEY.
